*Access Compliance Survey Report*

**Transition Plan update  
Buildings, Facilities, and Parks  
City of Alameda**

27003

April 4, 2008

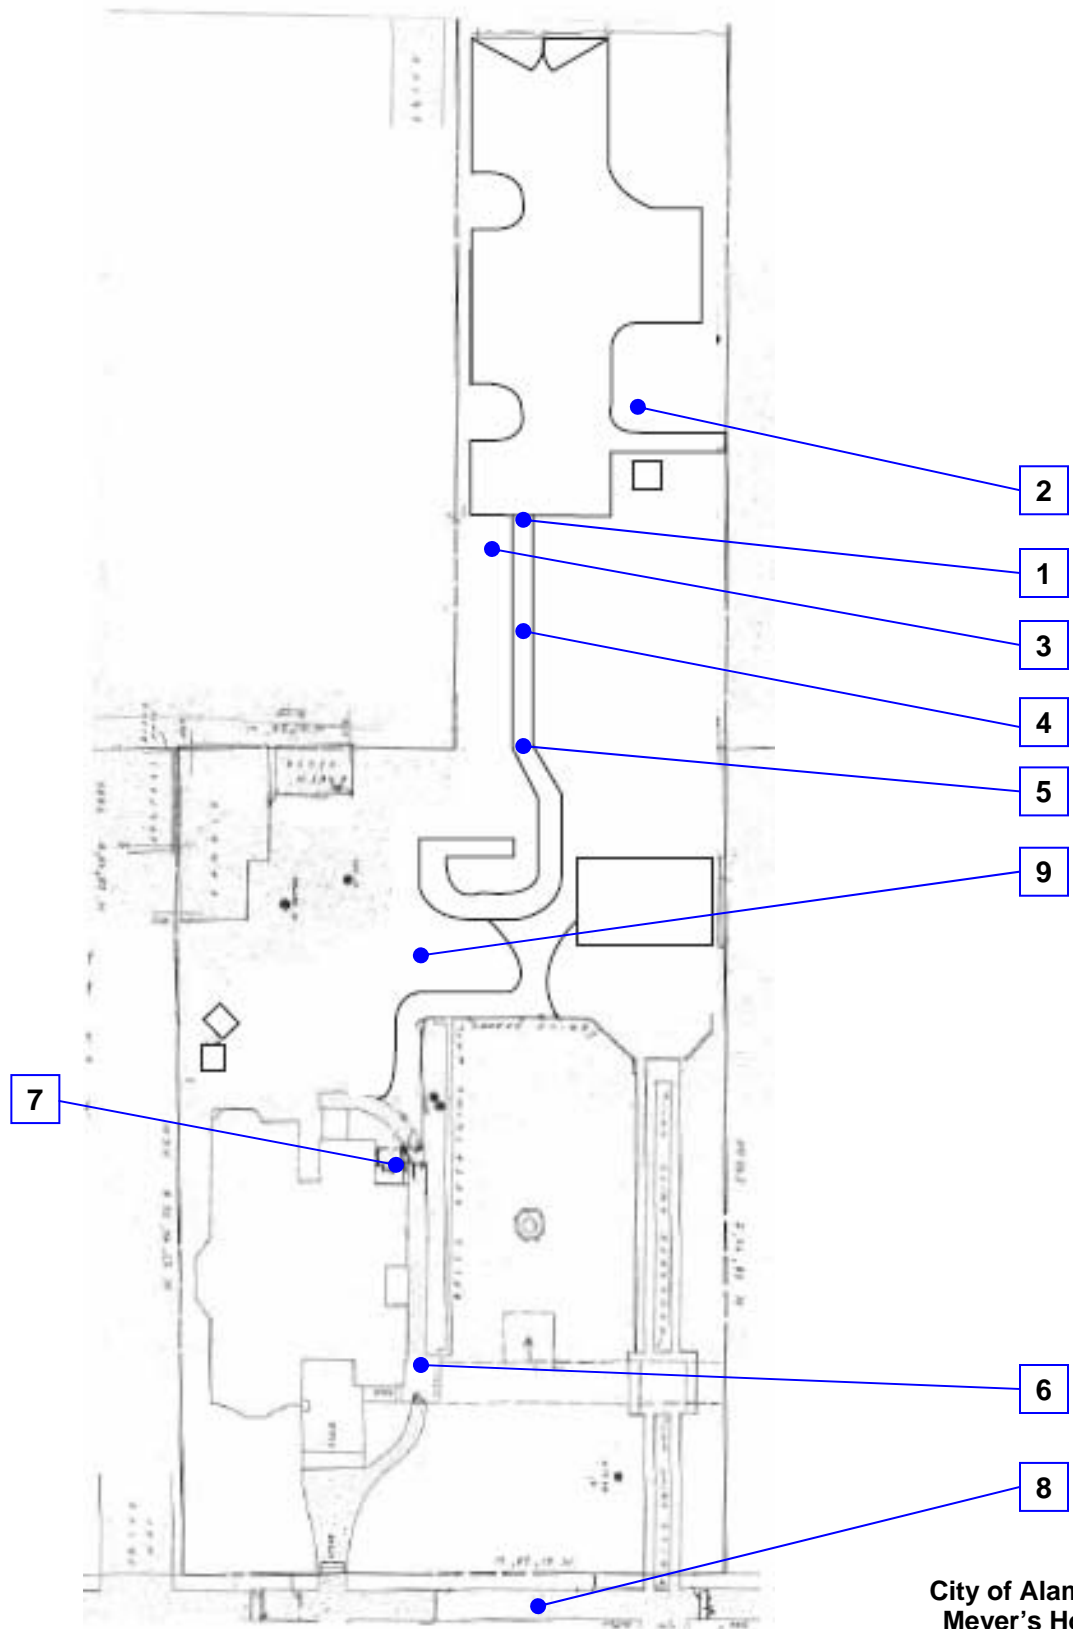
City of Alameda  
Meyer's House  
On-site, Exterior  
**2 - 0 - 1**

Item	Existing Architectural Barrier and Proposed Solution	Codes / Mitigation Info	Qty	Unit	Cost	Total
<b><u>Entrance Door</u></b>						
6895	<ul style="list-style-type: none"> <li>• <i>As-Built Description:</i> Public entrance not accessible to disabled persons.</li> <li>• <i>Proposed Solution:</i> Need wheelchair lift repaired to an operable condition.</li> </ul>	PCODE <b>ID04NT</b> ADAAG <b>4.14.1</b> CSAS <b>1134B.2.1</b>	1	JOB	\$500	<b>\$500</b>
<b><u>Ramp</u></b>						
6896	<ul style="list-style-type: none"> <li>• <i>As-Built Description:</i> Lift: Landing is not level.</li> <li>• <i>Proposed Solution:</i> Provide 60" x 60" square level landing(s).</li> </ul>	PCODE <b>EB05ANT</b> ADAAG <b>4.8.2</b> CSAS <b>1133B.5.4.1</b>	1	JOB	\$3,000	<b>\$3,000</b>
<b>8 Sidewalk</b>						
<b><u>Sidewalk</u></b>						
6898	<ul style="list-style-type: none"> <li>• <i>As-Built Description:</i> Sidewalk: Pavement dislocation creates vertical change in level between 1/4" and 1/2" in accessible route.</li> <li>• <i>As-Built:</i> 30</li> <li>• <i>Proposed Solution:</i> Grind or fill pavement dislocation to create beveled transition.</li> </ul>	PCODE <b>EF03A</b> ADAAG <b>4.5.2</b> CSAS <b>1133B.7.4</b>	1	SF	\$21	<b>\$21</b>

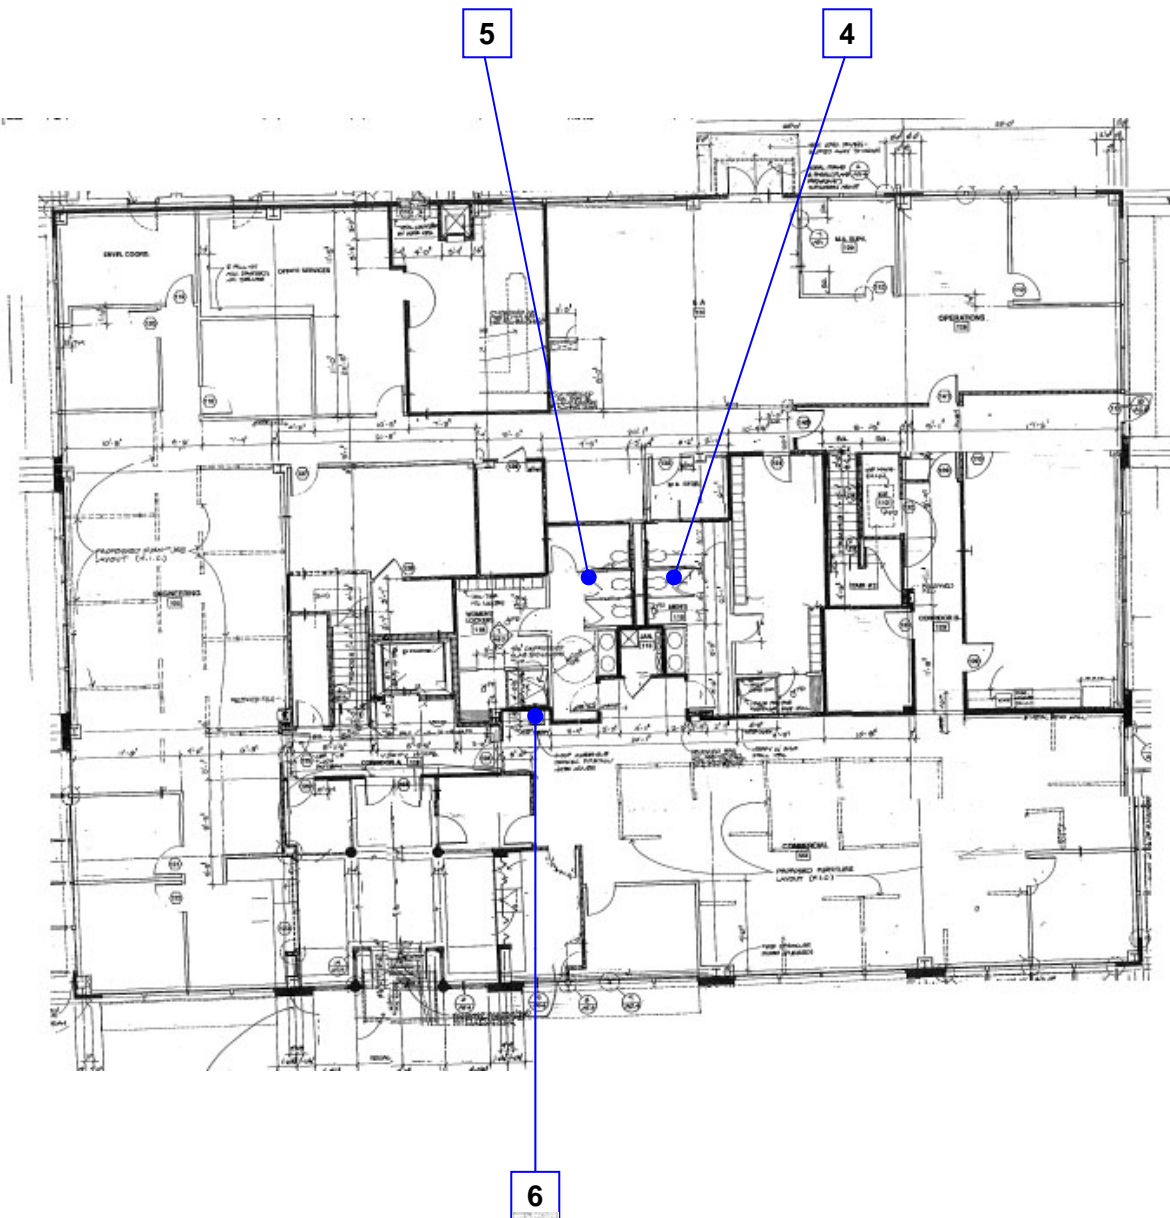
City of Alameda  
Alameda Power and Telecom  
Service Center  
Ground Floor  
**3 - 1 - 1**

<b>3 Signage</b>						
<b><u>Signage</u></b>						
6942	<ul style="list-style-type: none"> <li>• <i>As-Built Description:</i> Exterior signage at inaccessible entrances to provide direction to accessible entrances is missing or noncompliant.</li> <li>• <i>Proposed Solution:</i> Provide signage sufficient to guide persons to accessible entrances (need directional signage).</li> </ul>	PCODE <b>SA01</b> ADAAG <b>4.1.2(7)(e)</b> CSAS <b>1117B.5.7</b>	1	JOB	\$230	<b>\$230</b>
<b>4 Drop Box</b>

6919	<ul style="list-style-type: none"> <li>• <i>As-Built Description:</i> Rear grab bar less than 36" long or starting less than 42" from side wall. (CA only: less than 24" o.c. from water closet).</li> <li>• <i>Proposed Solution:</i> Recommended: Relocate existing accessible 36" long rear grab bar to start at 6" from side wall/partition and extend 24" beyond the center of the water closet toward the transer side of the stall.</li> </ul>	PCODE <b>WB07B</b> ADAAG <b>4.17.6</b> CSAS <b>1115B.8.1</b>	1	JOB	\$300	<b>\$300</b>
------	---	--	---	-----	-------	--------------

<b><u>Grab Bars</u></b>						
6923	<ul style="list-style-type: none"> <li>• <i>As-Built Description:</i> Rear grab bar less than 36" long or starting less than 42" from side wall. (CA only: less than 24" o.c. from water closet).</li> <li>• <i>Proposed Solution:</i> Recommended: Relocate existing accessible 36" long rear grab bar to start at 6" from side wall/partition and extend 24" beyond the center of the water closet toward the transer side of the stall.</li> </ul>	PCODE <b>WB07B</b> ADAAG <b>4.17.6</b> CSAS <b>1115B.8.1</b>	1	JOB	\$300	<b>\$300</b>

Item	Existing Architectural Barrier and Proposed Solution	Codes / Mitigation Info	Qty	Unit	Cost	Total
<b><u>Grab Bars</u></b>						
6938	<ul style="list-style-type: none"> <li><i>As-Built Description:</i> Rear grab bar less than 36" long or starting less than 42" from side wall. (CA only: less than 24" o.c. from water closet).</li> <li><i>Proposed Solution:</i> Recommended: Relocate existing accessible 36" long rear grab bar to start at 6" from side wall/partition and extend 24" beyond the center of the water closet toward the transer side of the stall.</li> </ul>	PCODE <b>WB07B</b> ADAAG <b>4.17.6</b> CSAS <b>1115B.8.1</b>	1	JOB	\$300	<b>\$300</b>
<b><u>Lavatory</u></b>						
6934	<ul style="list-style-type: none"> <li><i>As-Built Description:</i> Clear floor space, 30" x 48" in front of fixture, extending 19" max under the lavatory, not provided (CA only: Less than 18" from side wall to centerline of lavatory).</li> <li><i>Proposed Solution:</i> Relocate existing lavatory.</li> </ul>	PCODE <b>WD01A</b> ADAAG <b>4.19.3</b> CSAS <b>1115B.2.1.2.1</b>	1	JOB	\$900	<b>\$900</b>

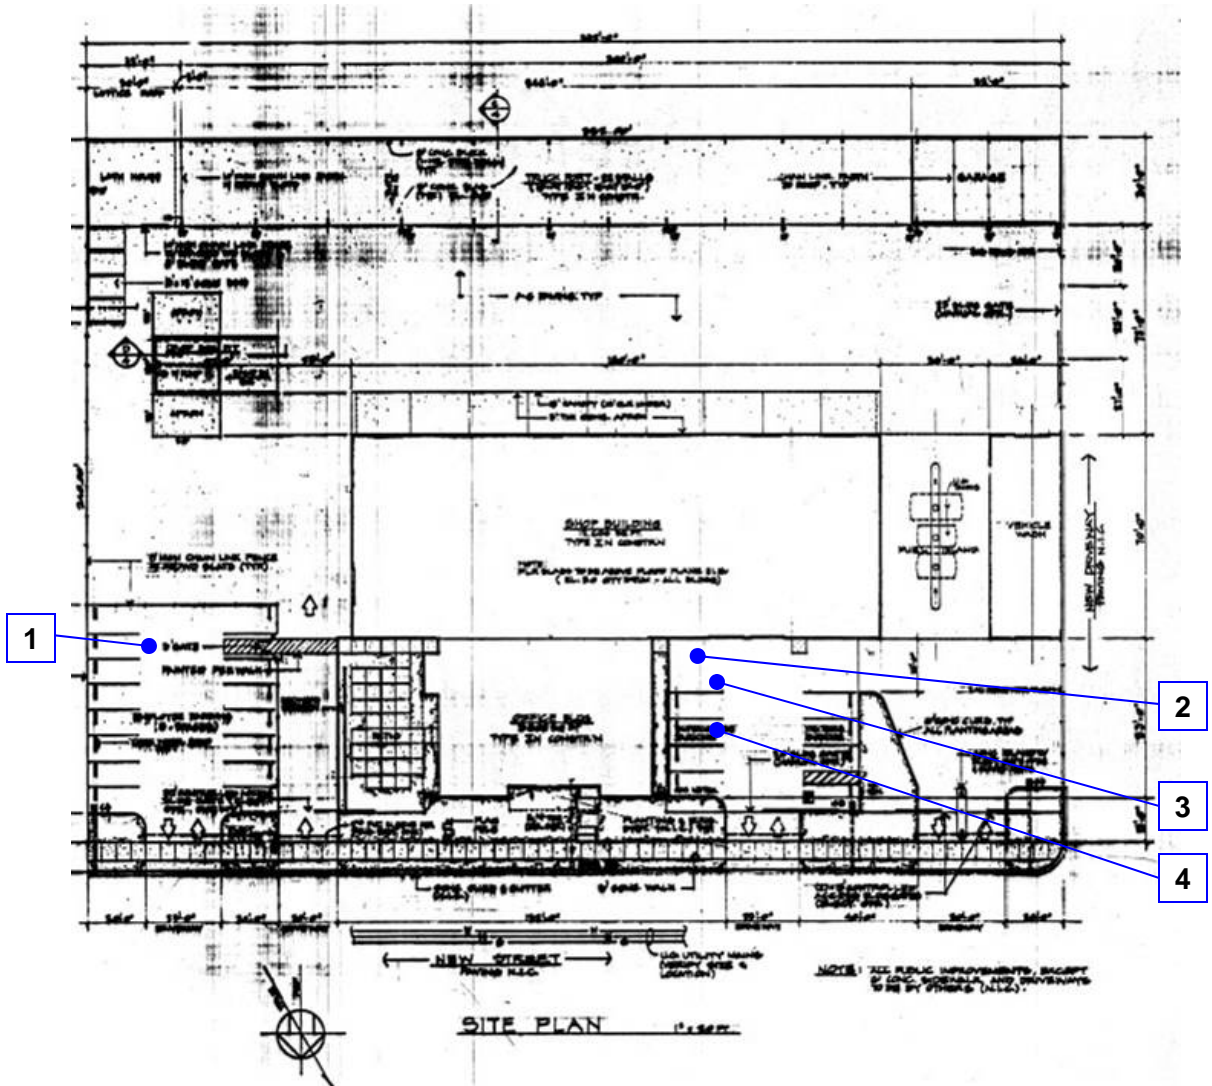
City of Alameda  
Corporation Yard Facility  
On-site, Exterior  
**4 - 0 - 1**

6954	<ul style="list-style-type: none"> <li><i>As-Built Description:</i> Existing threshold at door is less than 3/4" but without a beveled edge on both sides.</li> <li><i>Proposed Solution:</i> Door threshold 3/4" replace w/ compliant threshold.</li> </ul>	PCODE <b>ID02NT</b> ADAAG <b>4.1.6(3)(d)(ii)</b>	1	JOB	\$250	<b>\$250</b>
------	--	---	---	-----	-------	--------------

6962	<ul style="list-style-type: none"> <li>• <i>As-Built Description:</i> Multiple accommodation restroom not accessible; multiple compliance violations.</li> </ul>	PCODE <b>WA01A</b> ADAAG <b>4.22</b>	1	JOB	\$23,000	<b>\$23,000</b>
	<ul style="list-style-type: none"> <li>• <i>Proposed Solution:</i> Remodel area to provide accessible restroom with one accessible stall, lavatory (and one urinal at Mens).</li> </ul>	CSAS <b>1115B.7.1</b>

<hr/>						
<b><u>Water Closet</u></b>						
6972	<ul style="list-style-type: none"> <li>• <i>As-Built Description:</i> Flush Control: Operating handle not mounted toward wide side of stall, mounted more than 44" above floor and/or requires more than 5 lbs. force to operate.</li> <li>• <i>Proposed Solution:</i> Replace flush control with properly mounted accessible type.</li> </ul>	PCODE <b>WB10</b> ADAAG <b>4.16.5 &amp; 4.27.4</b> CSAS <b>1115B.2.1(2)</b>	1	JOB	\$500	<b>\$500</b>

6982	<ul style="list-style-type: none"> <li><i>As-Built Description:</i> Flush Control: Operating handle not mounted toward wide side of stall, mounted more than 44" above floor and/or requires more than 5 lbs. force to operate.</li> <li><i>Proposed Solution:</i> Replace flush control with properly mounted accessible type.</li> </ul>	PCODE <b>WB10</b> ADAAG <b>4.16.5 &amp; 4.27.4</b> CSAS <b>1115B.2.1(2)</b>	1	JOB	\$500	<b>\$500</b>
<hr/>						
<b>10 Coffee Bar at Corridor</b>						
<b><u>Sink</u></b>						
6984	<ul style="list-style-type: none"> <li><i>As-Built Description:</i> Kitchenette sink rim higher than 34" above floor.</li> <li><i>Proposed Solution:</i> Remodel sink cabinet to lower sink.</li> </ul>	PCODE <b>IN06</b> ADAAG <b>4.24.2</b> CSAS <b>1117B.3</b>	1	JOB	\$1,850	<b>\$1,850</b>

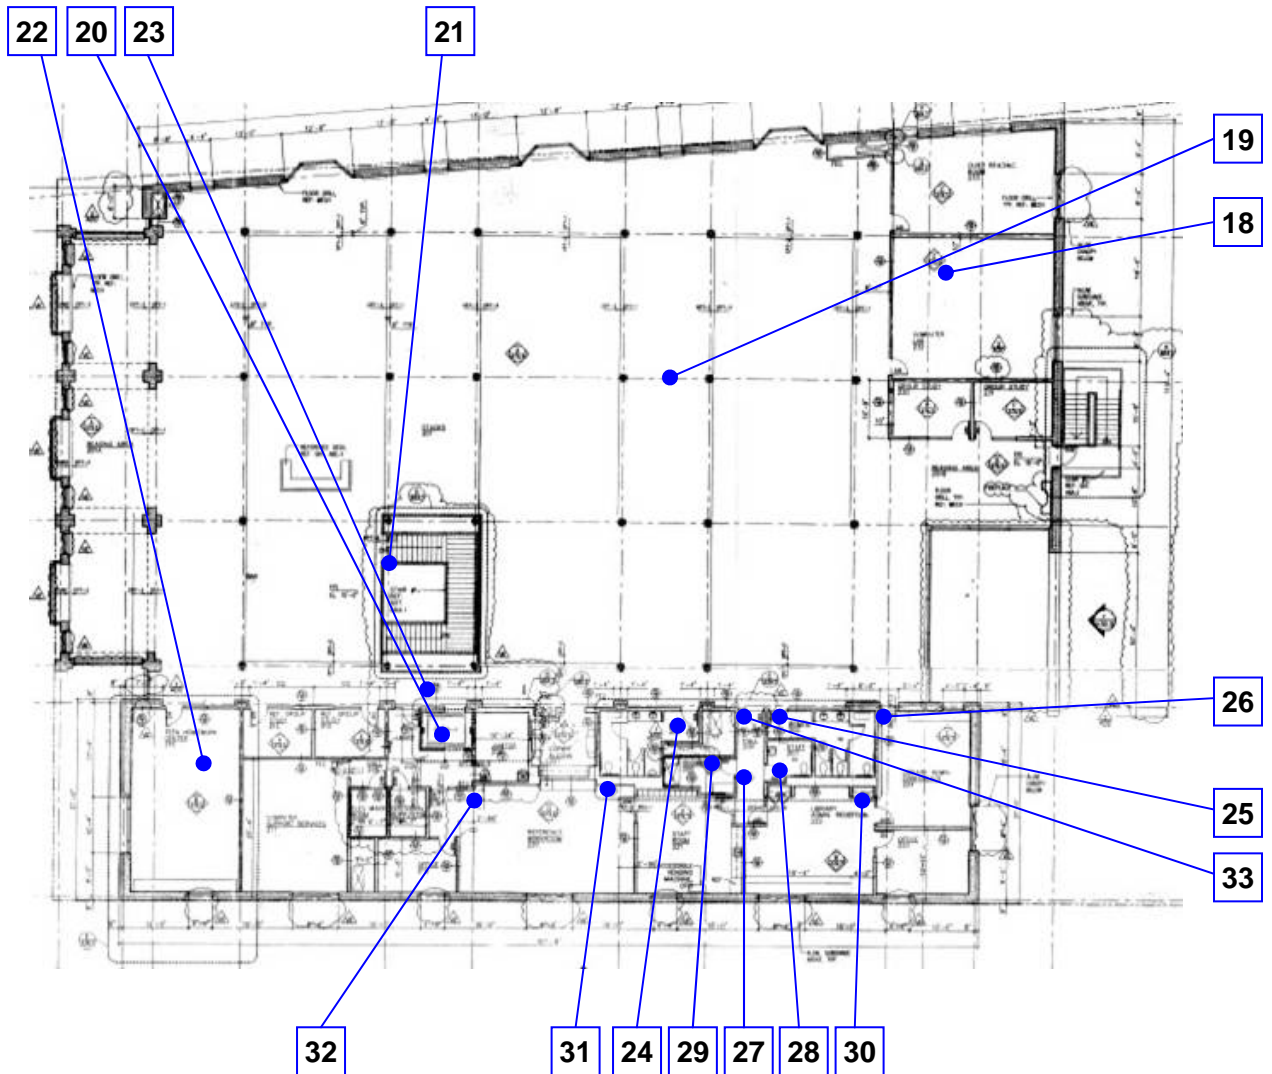
City of Alameda  
Main Library  
Second Floor, Interior  
**6 - 2 - 1**

Item	Existing Architectural Barrier and Proposed Solution	Codes / Mitigation Info	Qty	Unit	Cost	Total
<b><u>Signage</u></b>						
7015	<ul style="list-style-type: none"> <li>• <i>As-Built Description:</i> Otherwise compliant sign identifying permanent room or space not mounted 5' high to center on nearest adjacent wall, on latch side if a single door (located not to cause a Braille reader to stand within the door swing).</li> <li>• <i>Proposed Solution:</i> Relocate existing sign.</li> </ul>	PCODE <b>SA07</b> ADAAG <b>4.30.6</b> CSAS <b>1117B.5</b>	1	JOB	\$50	<b>\$50</b>
<b>17 Central Stairway</b>						
<b><u>Handrail</u></b>						
7016	<ul style="list-style-type: none"> <li>• <i>As-Built Description:</i> Stair handrail does not extend one tread width sloped plus 12" min horizontally beyond bottom riser.</li> <li>• <i>Proposed Solution:</i> Extend stair handrail at bottom (cost for each extension piece).</li> </ul>	PCODE <b>ED07</b> ADAAG <b>4.9.4(2)</b> CSAS <b>1133B.4.2.2</b>	2	JOB	\$500	<b>\$1,000</b>

7034	<ul style="list-style-type: none"> <li>• <i>As-Built Description:</i> Otherwise compliant sign identifying permanent room or space not mounted 5' high to center on nearest adjacent wall, on latch side if a single door (located not to cause a Braille reader to stand within the door swing).</li> <li>• <i>Proposed Solution:</i> Relocate existing sign.</li> </ul>	PCODE SA07 ADAAG 4.30.6 CSAS 1117B.5	1	JOB	\$50	\$50
------	---	--	---	-----	------	------

7035	<ul style="list-style-type: none"> <li>• <i>As-Built Description:</i> Otherwise compliant sign identifying permanent room or space not mounted 5' high to center on nearest adjacent wall, on latch side if a single door (located not to cause a Braille reader to stand within the door swing).</li> <li>• <i>Proposed Solution:</i> Relocate existing sign.</li> </ul>	PCODE SA07 ADAAG 4.30.6 CSAS 1117B.5	1	JOB	\$50	\$50
------	---	--	---	-----	------	------
