*Access Compliance Survey Report*

**Transition Plan update  
Buildings, Facilities, and Parks  
City of Alameda**

27003

April 4, 2008

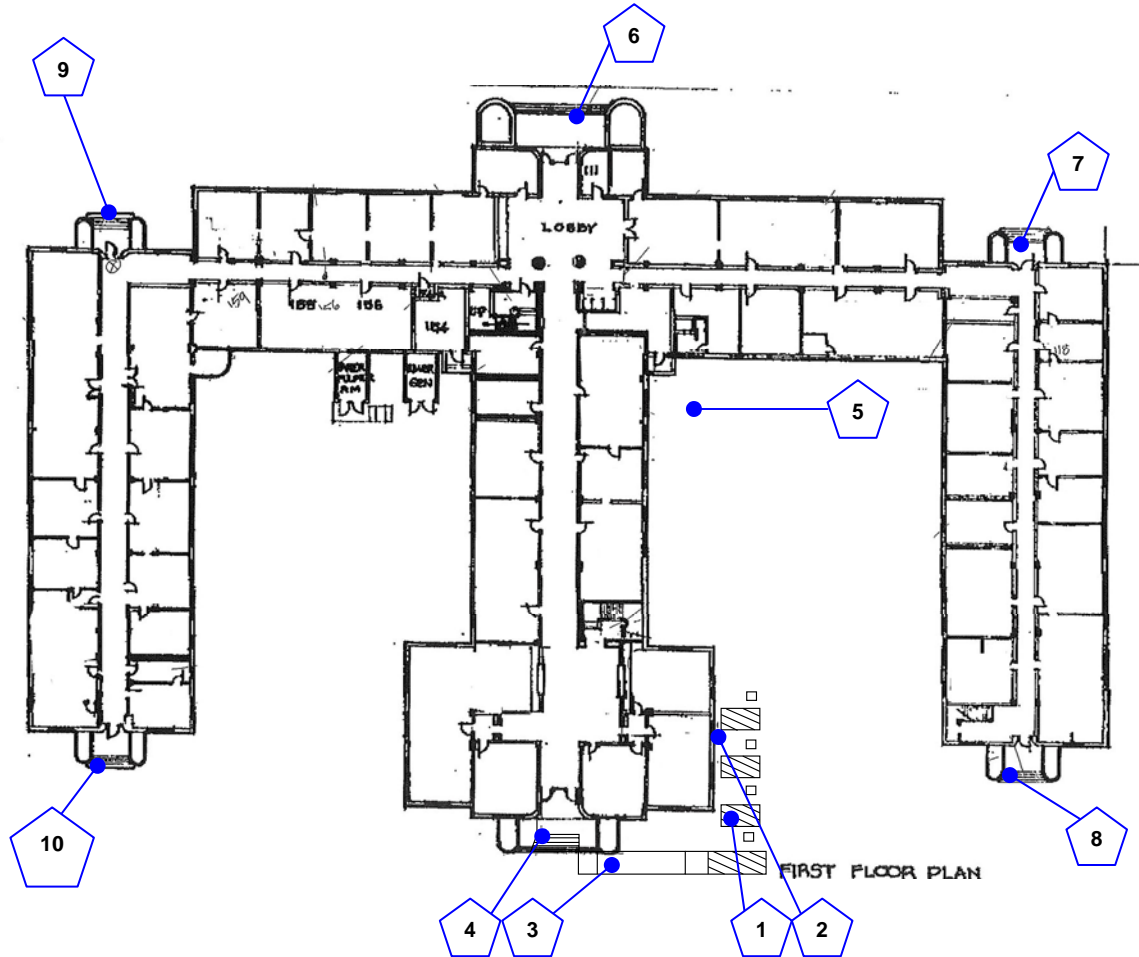
City of Alameda  
City Hall West  
On-Site, Exterior  
**34 - 0 - 1**

<b><u>Parking Aisle</u></b>						
8012	<ul style="list-style-type: none"> <li>• <i>As-Built Description:</i> Access aisle(s) at accessible parking space has slope greater than 1/4":12" (2%) &amp; level change exist.</li> <li>• <i>As-Built:</i> 3.3%; 2%</li> <li>• <i>Proposed Solution:</i> Modify slope at accessible parking space aisle.</li> </ul>	PCODE <b>EA05BNT</b> ADAAG <b>4.6.3</b> CSAS <b>1129B.4.4</b>	1	SF	\$12	<b>\$12</b>
<b><u>Parking Signage</u></b>						
8010	<ul style="list-style-type: none"> <li>• <i>As-Built Description:</i> Sign for accessible parking space is missing or non-compliant.</li> <li>• <i>Proposed Solution:</i> Provide compliant parking signage.</li> </ul>	PCODE <b>EA04B</b> ADAAG <b>4.6.4</b> CSAS <b>1129B.5</b>	4	JOB	\$315	<b>\$1,260</b>

8020	<ul style="list-style-type: none"> <li>As-Built Description: Bottom extension of handrail does not return creating a hazard for blind individuals.</li> <li>As-Built: 31"</li> <li>Proposed Solution: Remodel handrail return.</li> </ul>	PCODE <b>ED12</b> ADAAG <b>4.4.1</b> CSAS <b>1133B.4.2.3</b>	1	JOB	\$230	<b>\$230</b>
------	---	--	---	-----	-------	--------------

8023	<ul style="list-style-type: none"> <li>As-Built Description: Existing contrasting color strip faded. (Some needs to be replaced.)</li> <li>As-Built: 24' wide x 8 steps</li> <li>Proposed Solution: Provide contrasting color strips at all exterior stair treads when altering area.</li> </ul>	PCODE <b>EC02NT</b> CSAS <b>1133B.4.4</b>	192	LF	\$9	<b>\$1,728</b>
------	--	--	-----	----	-----	----------------

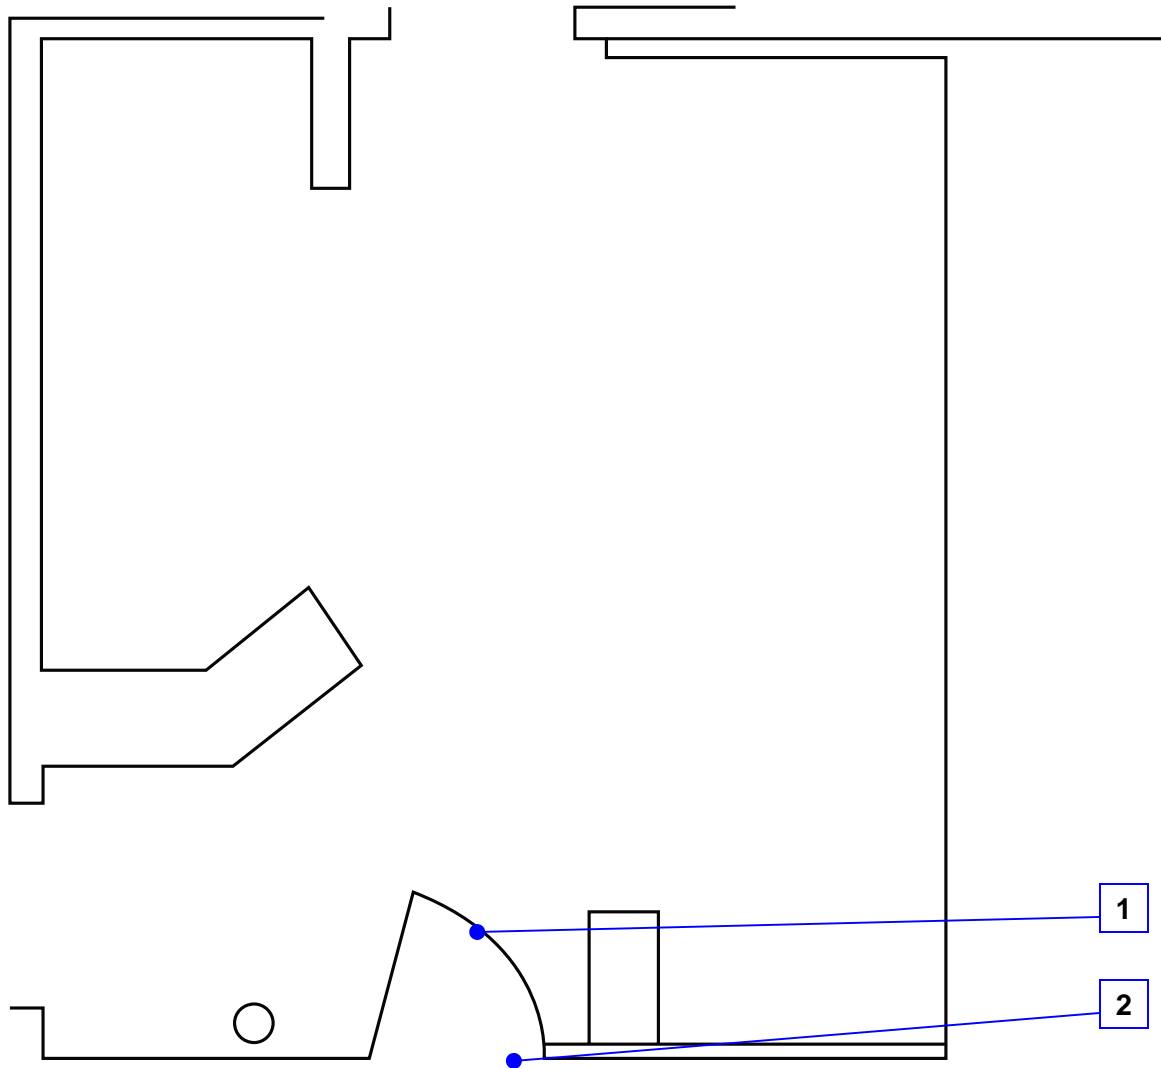
City of Alameda  
Fire Station 5  
First Floor, Interior  
**35 - 1 - 1**

<b>2 Uni-Sex Restroom</b>						
<b><u>Restroom</u></b>						
8207	<ul style="list-style-type: none"> <li>• <i>As-Built Description:</i> Single accommodation restroom not accessible; multiple compliance violations.</li> <li>• <i>Proposed Solution:</i> Remodel area to provide single-occupant accessible restroom.</li> </ul>	PCODE <b>WA01</b> ADAAG <b>4.22</b> CSAS <b>1115B.7.2</b>	1	JOB	\$17,000	<b>\$17,000</b>
<b>Total Costs for</b>					<b>Level: Ground</b>	<b>\$17,275.00</b>

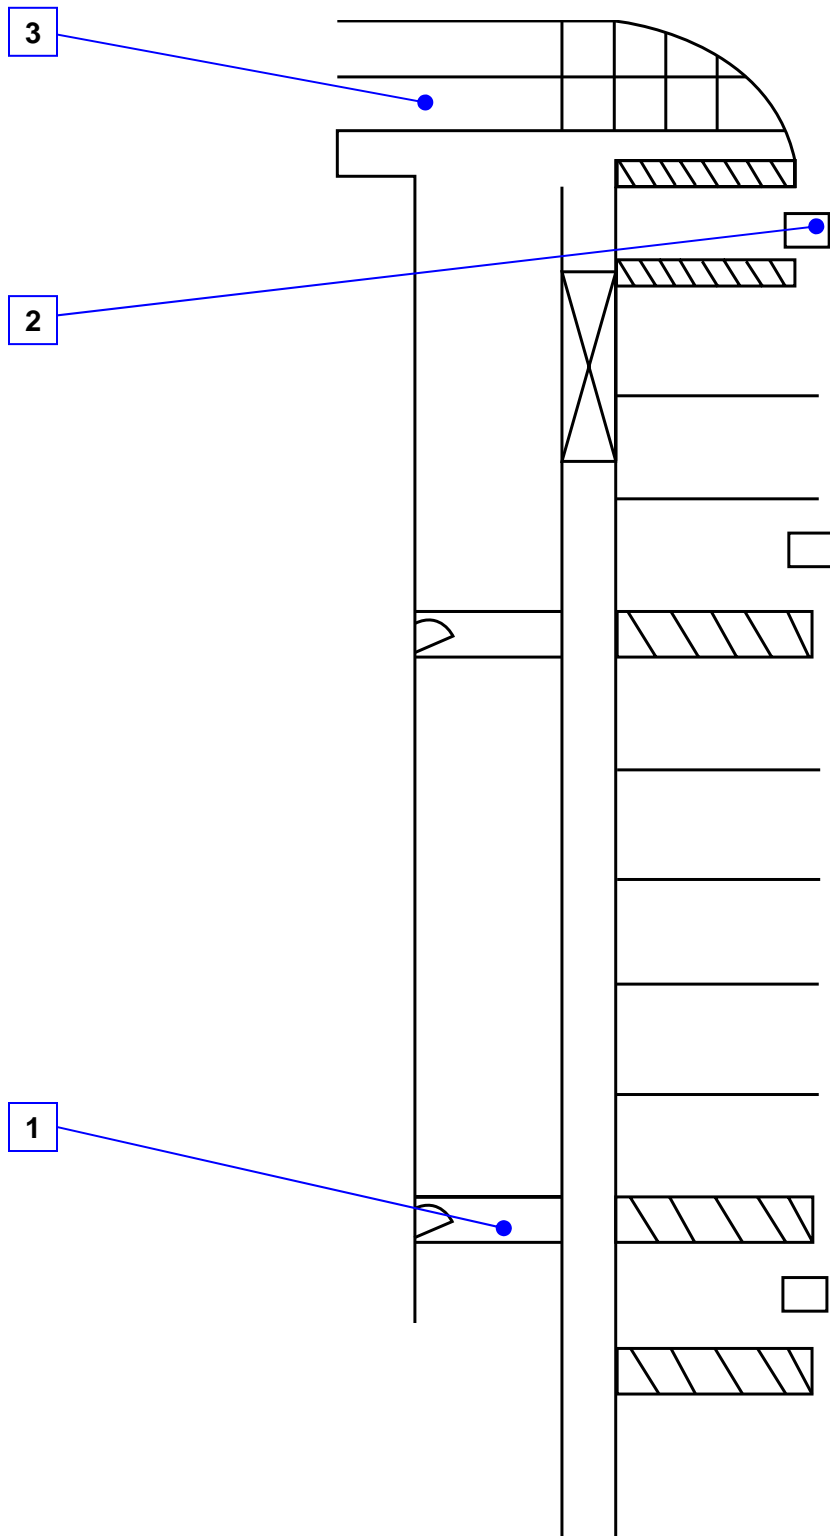
City of Alameda  
Alameda Point Gymnasium  
Site

Item	Existing Architectural Barrier and Proposed Solution	Codes / Mitigation Info	Qty	Unit	Cost	Total
<b>Sidewalk</b>						
8233	<ul style="list-style-type: none"> <li>• <i>As-Built Description:</i> Sidewalk: Pavement dislocation creates abrupt change in level exceeding 1/2" in accessible route.</li> <li>• <i>As-Built:</i> 6x5</li> <li>• <i>Proposed Solution:</i> Remove, replace or repair area of pavement sufficient to correct abrupt change in level.</li> </ul>	PCODE <b>EF03</b> ADAAG <b>4.5.2</b> CSAS <b>1133B.7.4</b>	30	SF	\$21	<b>\$630</b>
8234	<ul style="list-style-type: none"> <li>• <i>As-Built Description:</i> Sidewalk: Grating has grid openings greater than 1/2" along the line of traffic flow.</li> <li>• <i>As-Built:</i> 6x6</li> <li>• <i>Proposed Solution:</i> Provide new grating, with grid openings 1/2" max. along the line of traffic flow.</li> </ul>	PCODE <b>EF04</b> ADAAG <b>4.5.4</b> CSAS <b>1133B.7.2</b>	36	SF	\$80	<b>\$2,880</b>

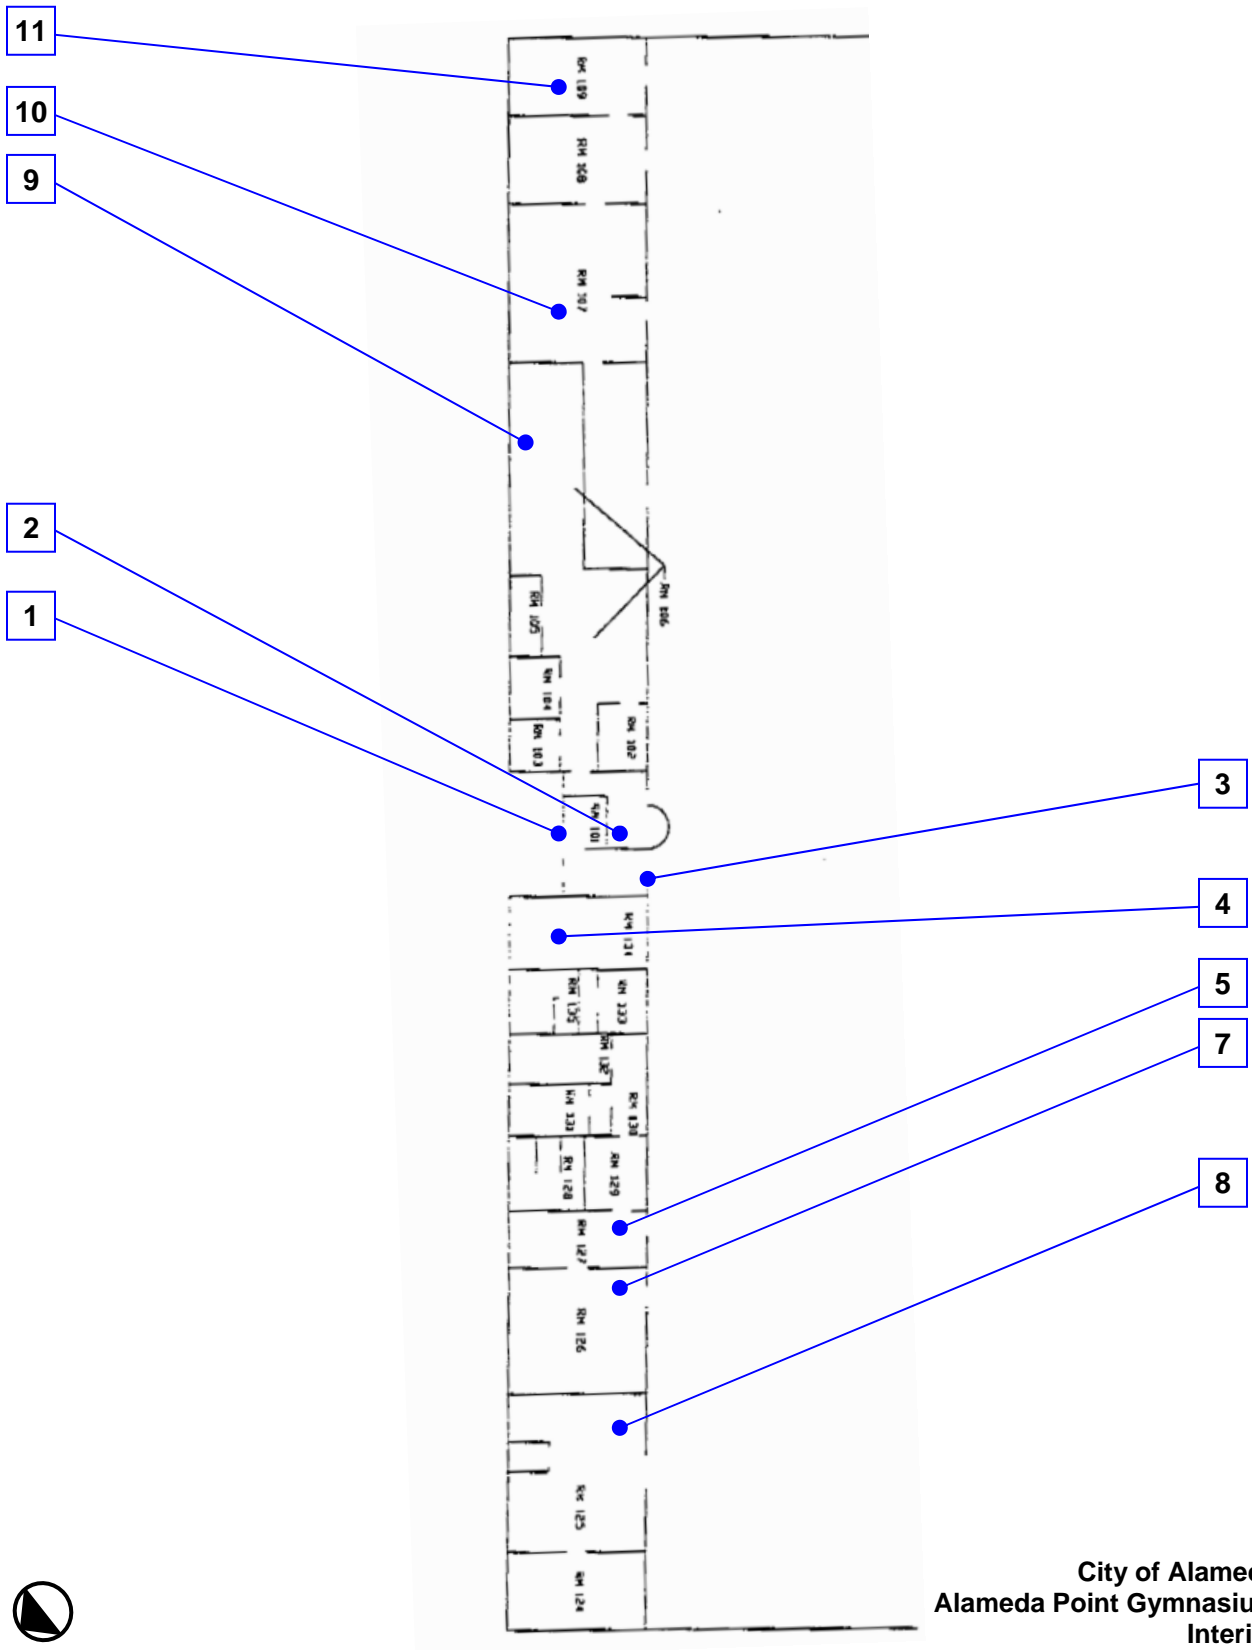
City of Alameda  
Alameda Point Gymnasium  
Interior  
**36 - 1 - 1**

Item	Existing Architectural Barrier and Proposed Solution	Codes / Mitigation Info	Qty	Unit	Cost	Total
<b><u>Restroom</u></b>						
8211	<ul style="list-style-type: none"> <li><i>As-Built Description:</i> Multiple accommodation restroom not accessible; multiple compliance violations.</li> <li><i>Proposed Solution:</i> Remodel area to provide accessible restroom with one accessible stall, lavatory (and one urinal at Mens).</li> </ul>	PCODE <b>WA01A</b> ADAAG <b>4.22</b> CSAS <b>1115B.7.1</b>	1	JOB	\$23,000	<b>\$23,000</b>
<hr/>						
<b>5 Room # 127 Women's Restroom</b>						
<b><u>Restroom</u></b>						
8212	<ul style="list-style-type: none"> <li><i>As-Built Description:</i> Multiple accommodation restroom not accessible; multiple compliance violations.</li> <li><i>Proposed Solution:</i> Remodel area to provide accessible restroom with one accessible stall, lavatory (and one urinal at Mens).</li> </ul>	PCODE <b>WA01A</b> ADAAG <b>4.22</b> CSAS <b>1115B.7.1</b>	1	JOB	\$23,000	<b>\$23,000</b>

Item	Existing Architectural Barrier and Proposed Solution	Codes / Mitigation Info	Qty	Unit	Cost	Total
<b><u>Restroom</u></b>						
8221	<ul style="list-style-type: none"> <li>• <i>As-Built Description:</i> Multiple accommodation restroom not accessible; multiple compliance violations.</li> <li>• <i>Proposed Solution:</i> Remodel area to provide accessible restroom with one accessible stall, lavatory (and one urinal at Mens).</li> </ul>	PCODE <b>WA01A</b> ADAAG <b>4.22</b> CSAS <b>1115B.7.1</b>	1	JOB	\$23,000	<b>\$23,000</b>
<hr/>						
<b>15 Pool Entrance Door</b>						
<b><u>Door Closer</u></b>						
8222	<ul style="list-style-type: none"> <li>• <i>As-Built Description:</i> Excessive effort required to operate door.</li> <li>• <i>As-Built:</i> 7lbs</li> <li>• <i>Proposed Solution:</i> Adjust regular door closer to accessible standards (5 lbs max).</li> </ul>	PCODE <b>ID03NT</b> ADAAG <b>4.13.11</b> CSAS <b>1133B.2.5</b>	2	JOB	\$25	<b>\$50</b>

Item	Existing Architectural Barrier and Proposed Solution	Codes / Mitigation Info	Qty	Unit	Cost	Total
<b><u>Restroom</u></b>						
8223	<ul style="list-style-type: none"> <li>• <i>As-Built Description:</i> Multiple accommodation restroom not accessible; multiple compliance violations.</li> <li>• <i>Proposed Solution:</i> Remodel area to provide accessible restroom with one accessible stall, lavatory (and one urinal at Mens).</li> </ul>	PCODE <b>WA01A</b> ADAAG <b>4.22</b> CSAS <b>1115B.7.1</b>	1	JOB	\$23,000	<b>\$23,000</b>
<b>17 Room # 130 Weight Room</b>						
<b><u>Door Hardware</u></b>						
8225	<ul style="list-style-type: none"> <li>• <i>As-Built Description:</i> Cabinet or storage door / drawer does not have accessible hardware.</li> <li>• <i>Proposed Solution:</i> Provide accessible pull / latch (touch latches or U-pulls).</li> </ul>	PCODE <b>ID07A</b> ADAAG <b>4.25.4</b> CSAS <b>1125B.4</b>	1	JOB	\$100	<b>\$100</b>

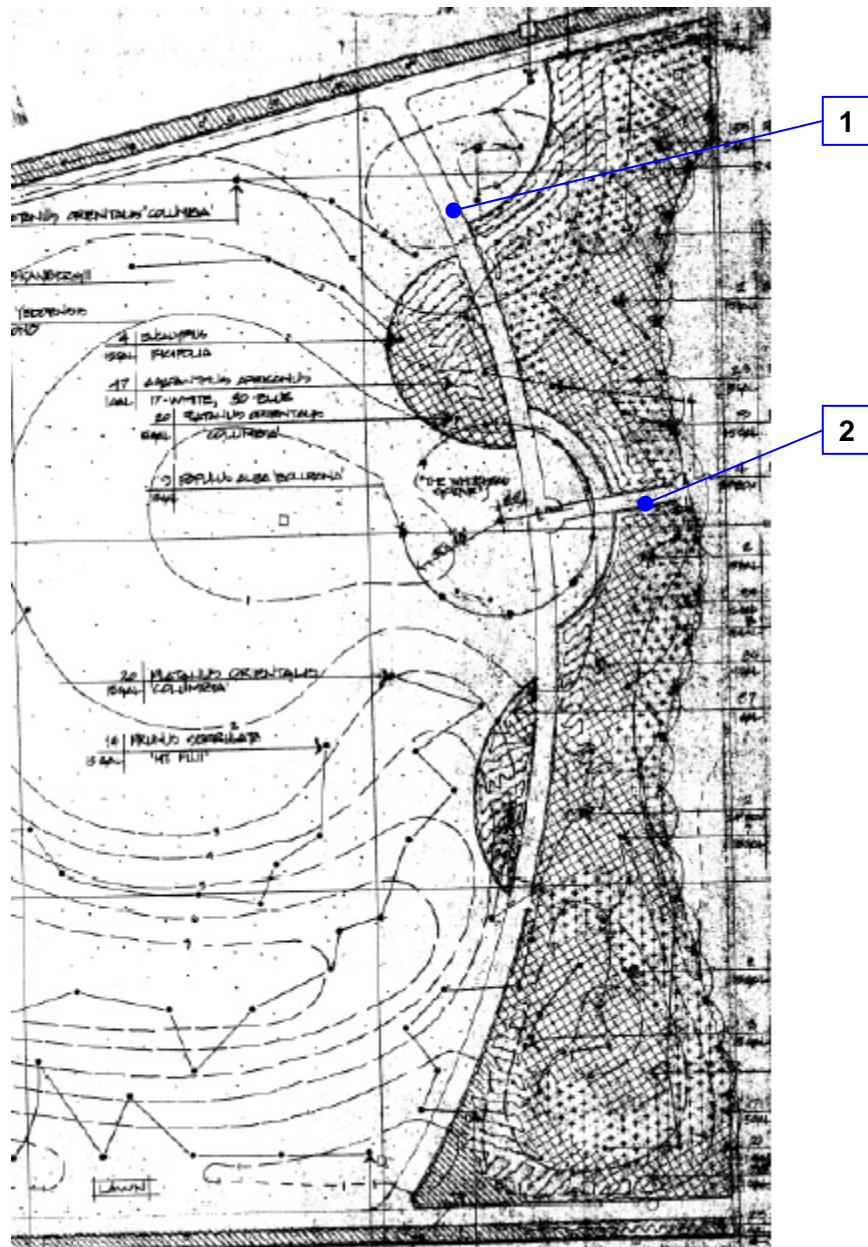
City of Alameda  
Neptune Park  
On-site, Exterior  
**38 - 0 - 1**

<hr/>						
8377	<ul style="list-style-type: none"> <li>• <i>As-Built Description:</i> Sidewalk: Pavement dislocation creates abrupt change in level exceeding 1/2" in accessible route.</li> <li>• <i>As-Built:</i> 1" ledge</li> <li>• <i>Proposed Solution:</i> Remove, replace or repair area of pavement sufficient to correct abrupt change in level.</li> </ul>	PCODE <b>EF03</b> ADAAG <b>4.5.2</b> CSAS <b>1133B.7.4</b>	10	SF	\$21	<b>\$210</b>
<hr/>						
8383	<ul style="list-style-type: none"> <li>• <i>As-Built Description:</i> Sidewalk: Pavement dislocation creates abrupt change in level exceeding 1/2" in accessible route.</li> <li>• <i>Proposed Solution:</i> Remove, replace or repair area of pavement sufficient to correct abrupt change in level.</li> </ul>	PCODE <b>EF03</b> ADAAG <b>4.5.2</b> CSAS <b>1133B.7.4</b>	10	SF	\$21	<b>\$210</b>
